## **Technical Report**

## Huachocolpa Uno Mine Property, Huancavelica Province, Peru

#### **Endeavour Silver Corp.**

Report Date: March 27, 2025 Effective Date: December 31, 2024

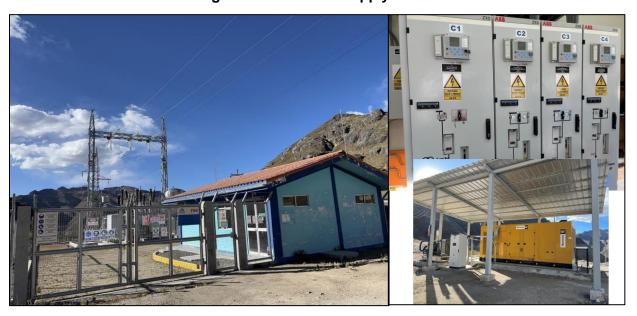
Figure 5-1 Power supply station

- Power transmission line, high voltage, 60 kV
- Kolpa's 60 kV to 22.9 kV electrical substation.

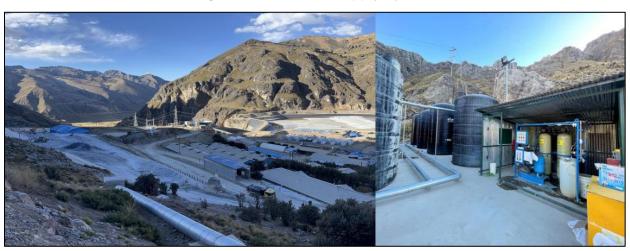
Figure 5-2 Water supply system

- Water Treatment Plant (NCD) and Mine Water Treatment Plant
- Caudalosa Drinking Water Treatment Plant
- Comihuasa Drinking Water Treatment Plant

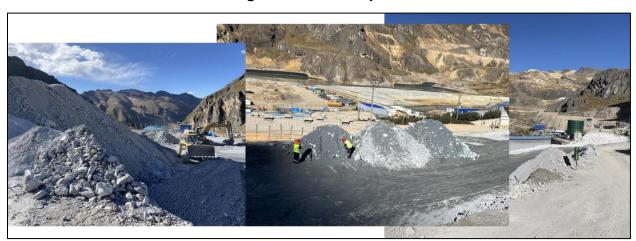
Figure 5-3 Stockpiles

Huachocolpa Uno processing stockpile platform

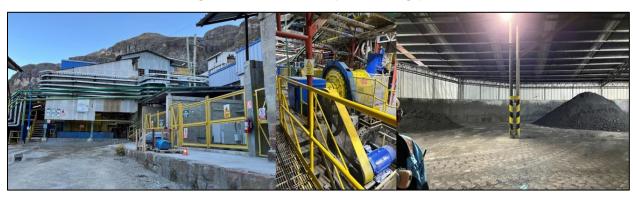
Figure 5-4 Mineral processing plant

Huachocolpa Uno processing plant has a capacity of approximately 1,800 tpd.

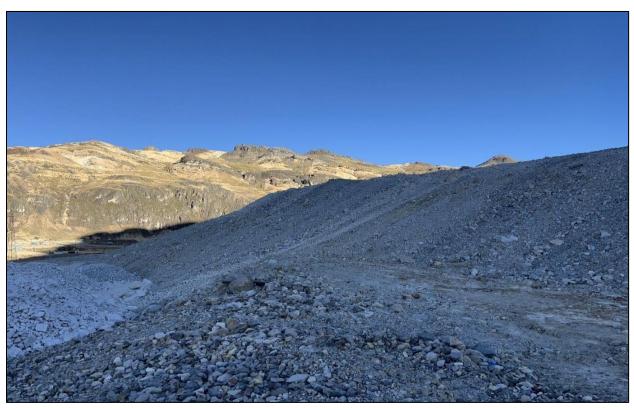
Figure 5-5 Waste dump area

Rublo waste dump

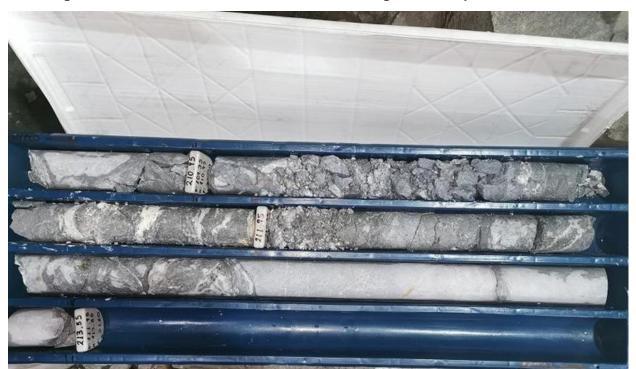
Figure 11-1 Plastic core-holder box with strong lid and depth marker blocks

During drilling campaigns, drill core samples are transported by Kolpa staff on a daily basis from either the surface drilling rig platform or underground drill chamber, to the Kolpa core shed facility. The core is packed in strong, appropriately designed plastic core boxes, marked with the drill hole number, from-to meters

drilled and box number. Each box is carefully sealed with a plastic lid (Figure 11-1), before being placed in a 4x4 truck and securely tied down for transport to the central warehouse.

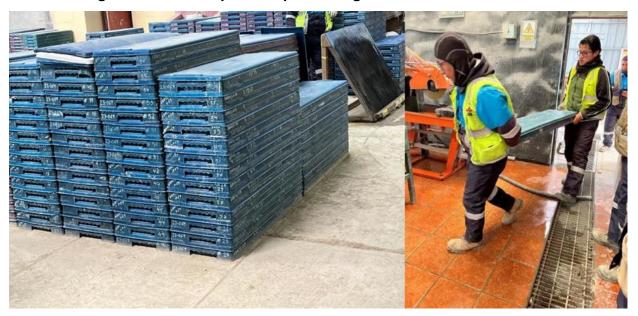
Figure 11-2 Transport and processing of diamond drill core-boxes

The samples are accompanied by the respective chain of custody documents, duly filled out and signed, according to the Kolpa in-house procedure "PETS-GEO-021: TRANSFER OF PERSONNEL AND SAMPLES WITH LIGHT EQUIPMENT" (Figure 11-2).

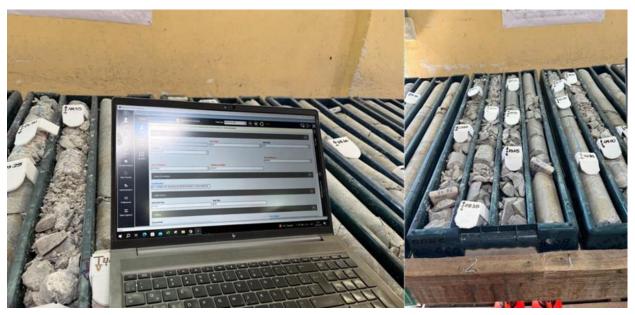
The logging geologist, on the basis of geological observations [lithology, hydrothermal alteration, mineralogy and identification of mineralized structures, etc.], identifies DDH core to be analytically analysed for its mineral content (Figure 11-4). This activity is conducted in accordance with internal Kolpa procedures, "PETS-GEO-005: DETAILED GEOLOGICAL LOGGING" and "PETS-GEO-006: LOGGING QUALITY CONTROL". In zones of potential economic interest, the geologist determines which core intersections are to be sampled as well as the length of each sample and prepares the relevant drill core sampling form. Depending on the nature and importance of the mineralization being intersected, sample lengths can range from 0.10 m to 2.50 m in length. Prior to delivery of the samples to the analytical laboratory, the geologist will specify the insertion of QAQC control samples, including various combinations of certified reference material (of either low, moderate or high grade), fine & coarse blank samples, twin samples and fine & coarse duplicate samples.

A unique sample number is assigned to each designated sample interval and inserted quality control (QC) sample. The range (from and to) of each sample and appropriate descriptive geological comments, are entered into the drill log. The sample range and sample number are also tagged on the core box.

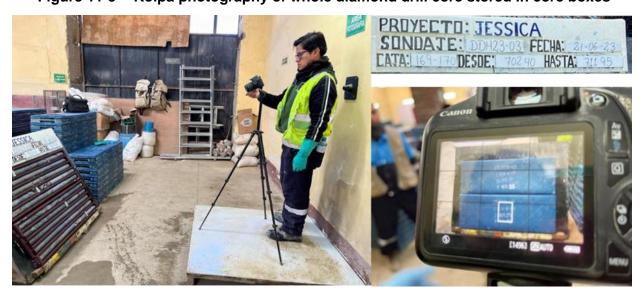
Figure 11-5 Kolpa photography of whole diamond drill core stored in core boxes

Once the geologist completes the logging, the process of identifying core for sampling, and the appropriate tagging and data recording into the database has been undertaken, then the drill core boxes are delivered to the geo-technician and a photographic record of all core boxes belonging to each hole is made prior to splitting and sampling of the drill core (Figure 11-5).

Drill core is photographed wet according to the Kolpa protocol "PETS GEO-016: PHOTOGRAPHIC RECORD OF DRILL HOLE CORES".

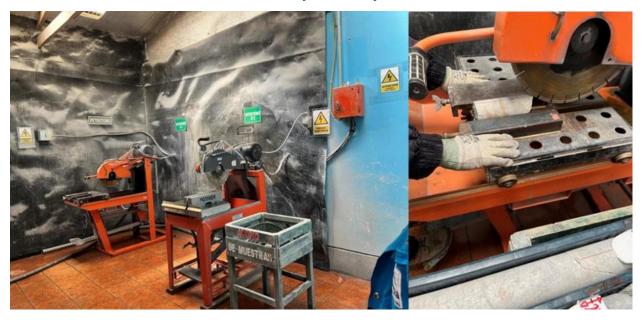
Figure 11-6 Kolpa symmetrical splitting of mineralized core in preparation for sampling and analytical analysis

In accordance with the internal Kolpa protocol "PETS GEO-019: CORE SPLITTING & SAMPLING", the drill core is symmetrically split with a diamond saw by cutting along 'core- splitting lines' as defined and marked-out by the logging geologist (Figure 11-6). After the symmetrical splitting of the core, taking great care to avoid any form of contamination between samples, the right-hand half of the split core is collected for sampling and packaged in duplicated sample bags of resistant and transparent plastic. Together with a coded sample number ticket, the core sample is placed into the sample bag and the bag is sealed. The sealed and labelled sample is then coded and weighed in preparation for delivery to the analytical laboratory.

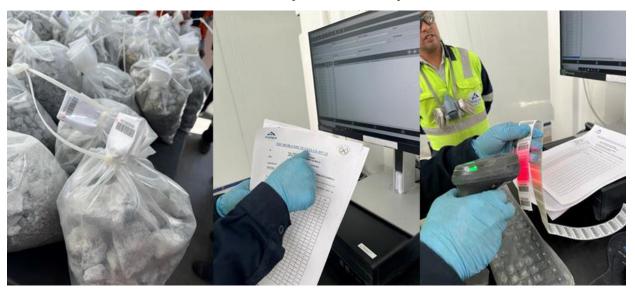
Figure 11-8 Receipt of samples and capture into the LIMS system at the Kolpa minesite analytical laboratory

Upon reception in the laboratory (Figure 11-8), the sample batch is registered in the internal Laboratory Information Management System 'LIMS' and assigned a work order number known as the internal batch. Each time a sample advances through the laboratory process, the system monitors the activity providing an indication of at what stage the sample is in the preparation and/or analytical process.

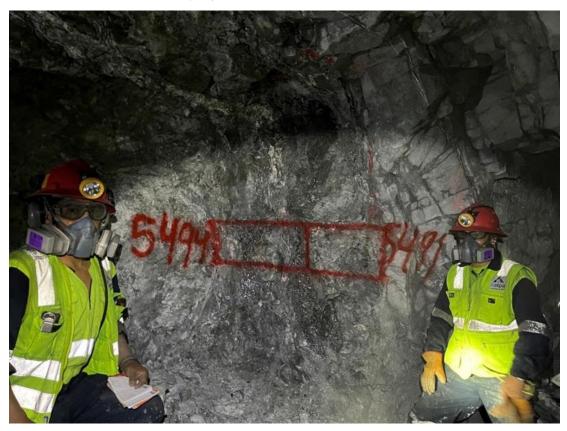
Figure 11-9 Marked-out sub-horizontal channel sample on a sub-vertically oriented polymetallic vein

- where potentially economic mineralization of interest is intersected. The senior sampler then traces the limits of the site to be sampled with red spray-paint.
- 4. Given that the mineralized polymetallic structures at Kolpa are generally sub-vertical, the CHN sample, usually located at the working-face of a drive or drift along the structure (Figure 11-9), will be collected in sub-horizontal fashion across the face of the structure, with the sample width measured along an orientation perpendicular to the strike of the vein.

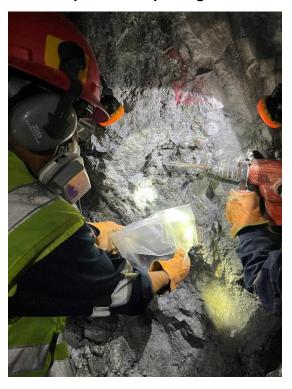
Figure 11-10 Collection of a channel sample from the mineralized structure directly into a plastic sample bag

- 6. The senior sampler and his assistant then proceed to collect the channelled sample with the use of a tungsten-tipped electric 'hammer-action' chisel. The CHN sample is collected directly into a strong plastic bag (Figure 11-10). In the case that fragments are collected which are considered to be too large and which may bias the sample, the senior sampler will place the fragment over a clean, impermeable sheet, and homogenize the size of the sample fragments before, careful to avoid any form of sample contamination or bias, will place the fragments into the sample bag.

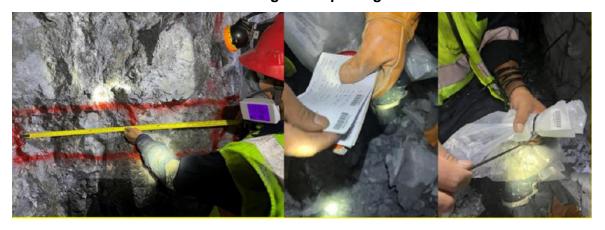
Figure 11-11 Measuring limits of a sub-horizontal channel sample; coded sample tags and sealing of sample bag

7. Each sample is coded and then, including a sample-ticket inserted into each CHN sample bag for easy identification purposes, it is double-wrapped (Figure 11-11). Once collection of the sample from the rock-face is completed, it is sealed with a security seal before, in compliance with the chain of custody protocol, it is stored together with other samples in a canvas backpack to be taken to the sample storage shed. Here it will be packed together with several other samples into larger sample batches, before being transported and delivered to the analytical laboratory.

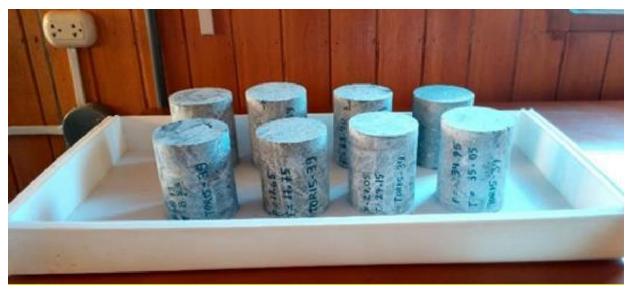
- b. DDH core samples greater than approximately 10 cm (Figure 11-13) and representative of the targeted intersection are selected. If the DDH core is quite fractured (broken) and a 10 cm piece is not available, a semi-regular piece of at least 5 cm in length as a minimum is selected. Similarly-sized samples from CHN sampling are selected for BD determination.

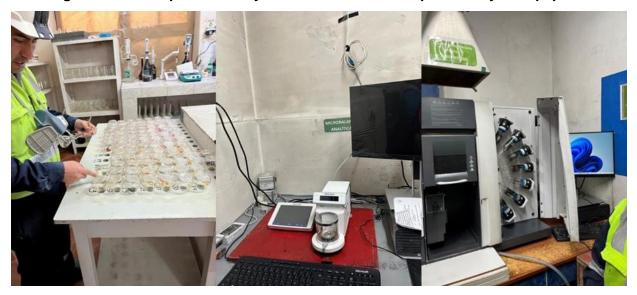
Figure 11-17 Kolpa laboratory modern Atomic Absorption analysis equipment

Upon the completion of sample preparation for each sample batch delivered for the analytical analysis for Ag, Cu, Fe, Pb and Zn, the Kolpa Laboratory performs the analyses utilizing 0.125 g aliquot samples digested with aqua regia and finished with the Atomic Absorption Spectroscopy (AAS) Agilent-280 method (Figure 11-17). When the Pb, Zn, Cu and Fe elements detection concentration exceeds the 9.99% upper limit of this method, the sample is then subjected to the Volumetric EDTA method for determination of the higher-grade metal concentrations of the sample. Ag (oz/Tm) that are greater than 9.99% are determined by Fire Assay with a gravimetric finish.
